TEST DRIVE TECHNOLOGIES VEHICLE INSPECTION SERVICES

Vehicle Identification

Inspection Date: 3/30/2018

VIN IN6AA0CC3FN501514	Trim: KING CAB PRO 4X
Year: 2015	Vehicle Type: PICKUP
Make: NISSAN	Number of Doors: 2+2
Model: TITAN	Engine Size: V8 5.6 L
Mileage: 17,442	Transmission Type: AUTOMATIC
Hours: NA	Driveline Type: 4WD

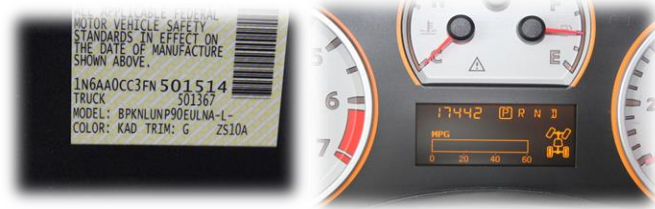
MOTOR VEHICLE SAFETY
STANDARDS IN EFFECT ON
THE DATE OF MANUFACTURE
SHOWN ABOVE.
IN6AA0CC3FN 501514
TRUCK 501367
MODEL: BPNLUN90EULNA-L-
COLOR: KAD TRIM: G ZS10A

Section Notes: VIN VERIFIED BY B PILLAR, WINDSHIELD AND OBD
